**USAID, Sri Lanka Tsunami Reconstruction Assistance Program
(STRAP)**

Initial Environmental examination (IEE) Report

(Draft dated May 03, 2005)

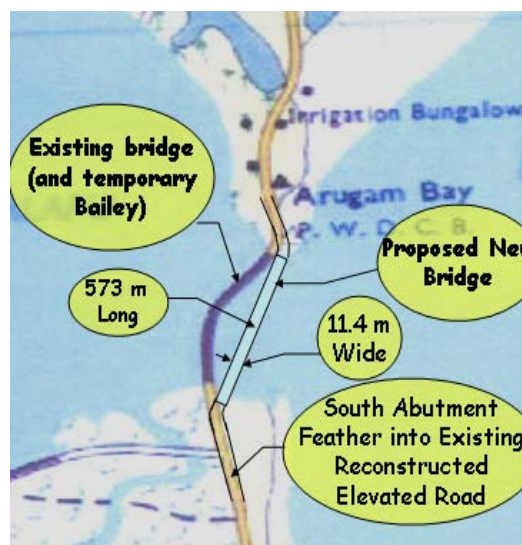
Figure 3: Location of the Present and Proposed Bridges at Arugam Bay

Design and Construct a replacement bridge on a new alignment and on the east side of the existing Arugam Bay Bridge. The total length of the new bridge will be about 686 meters long. The total width will be 11.4 m to provide 7.4 m carriageway for two lanes of traffic with 2.0m wide foot walks on either sides. The foundation will be either large diameter bored piles or large diameter caissons taken to bedrock. The same free board shall be used as the existing bridge. The same vertical clearance shall be maintained between the soffit of the superstructure and to the waterway below. The vertical profile of the approaching roads and bridge will require adjustment to accommodate the depth of the new superstructure. The new bridge will be of concrete construction. The existing bridge will be used as a detour until the new bridge is constructed. The existing bridge will be removed and the existing causeway demolished after the new bridge is operational.

The Superstructure will consist of five 1.8 meters deep Post-Tensioned concrete girders, spaced at 2.4 meters center to center spacing.

The bridge will consist of twenty one 32.7 m long spans. The deck will either be 200mm thick cast in place concrete crowned at the center with 2% slope, or 100mm thick pre cast deck with 100mm thick cast in place concrete topping crowned at the center with 2% slope. A 7.5 meter long approach slab should be provided at each approach of bridge to give a smooth riding surface at the road/bridge transition.

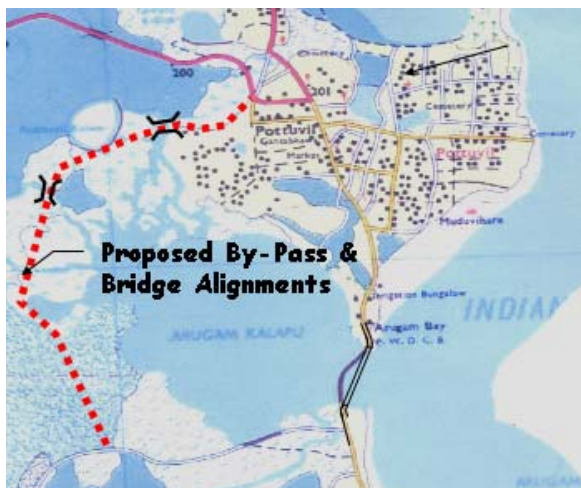
Figure 4: Proposed Arugam Bay by-pass road and bridge locations

The new bridge will eliminate the need for a causeway on the south side which restricted the lagoon water flow and could not resist the intensity of waves and water flow at turbulent weather. The new bridge will have a more direct alignment with the existing roads on the north and south approaches and will be 3.8 meters wider than the existing steel truss bridge to accommodate future widening of the approaching roads. The new bridge will require minimal maintenance since it will be constructed with concrete as

opposed to the steel bridge that lacks durability in the salt water environment. Restoration of the wetlands as a result of eliminating the causeway is a direct environmental benefit.
